In Brief: Glebe Harbor-Cabin Point POA Reserve Study

At the end of 2016, the board of directors decided to have an independent reserve study completed by Miller Dodson. A reserve study is an analysis by a specialized professional firm of all capital assets, assets with a useful life of more than 1 year and whose value exceeds a certain amount. This analysis does the following:

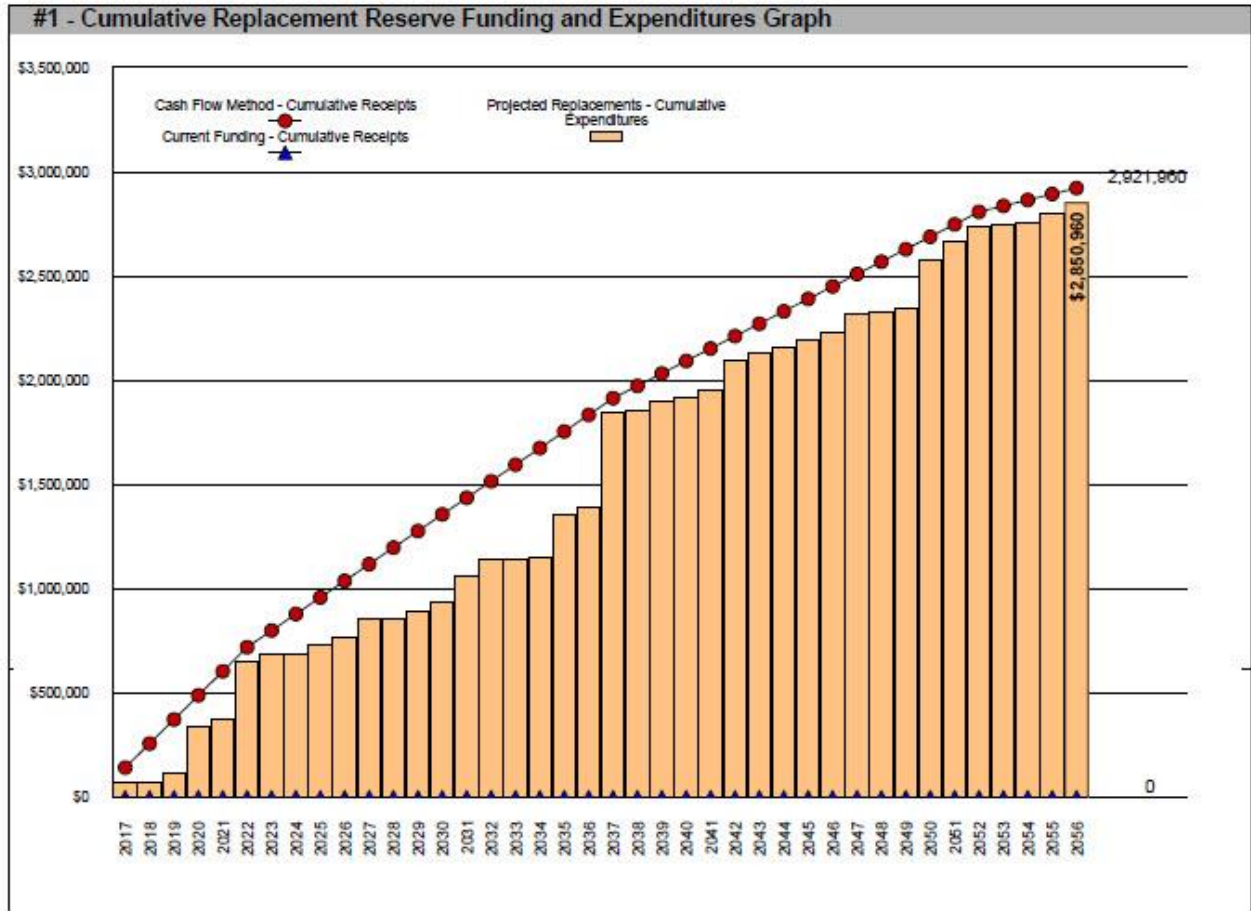
The graphic below summarizes the current status of capital reserve funding for the POA/SD. The yellow bars represent the annual expenditures estimated in the reserve study to maintain the existing capital assets. The blue triangle at the bottom represents the current level of reserve funding, which is \$0. The

red dotted line represents the cumulative receipts needed to fund existing capital asset maintenance.

The reserve study indicates that the POA/SD will need to fund \$141,937 for the first year and then an average of \$71,274 thereafter per year to provide for sufficient funding of all capital repairs and replacements over the next 40 years. The recommended amounts vary per year and are higher in the first 8 years as shown in the following table.

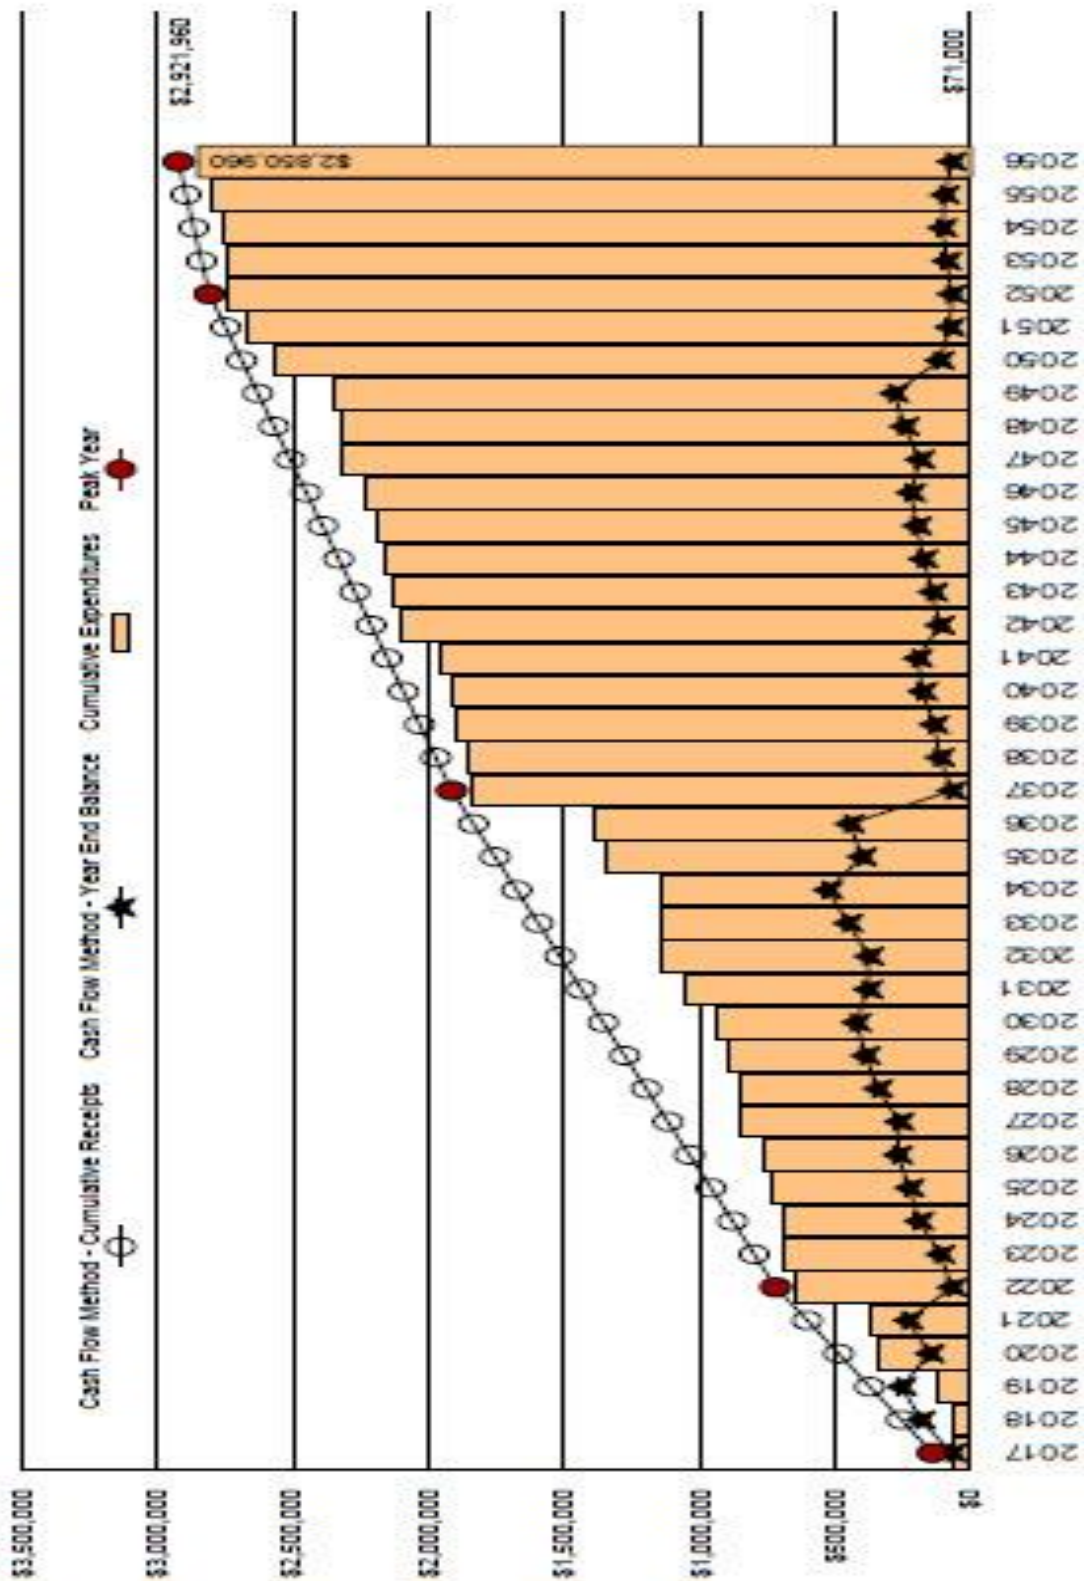
#4 - Cash Flow Method - Graph of Cumulative Receipts and Expenditures - Years 1 through 40

The graph below shows the capital expenditures as a gold bar, cumulative funding as the open circle line, year-end reserve fund balance as the blue triangle and the red circle as peak year expenditures. It is assumed in these reserve study calculations that all capital expenditures are self-funded through savings and not through debt financing. The impact of the use of debt financing will have to be taken into account separately in our long-term planning process.

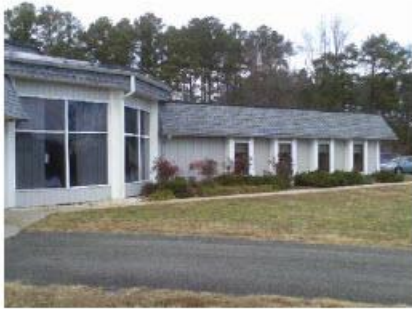
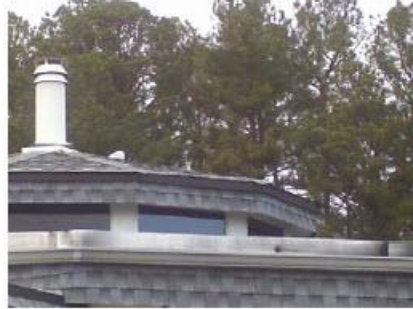
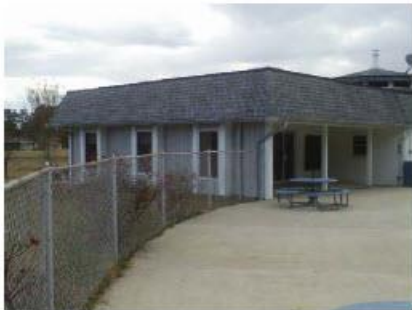
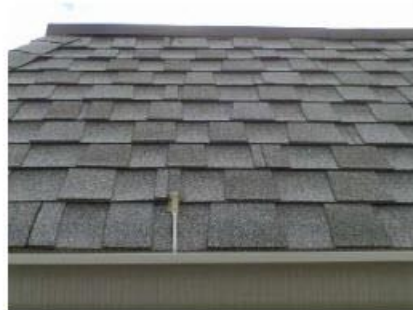
CLUBHOUSE BUILDING EXTERIOR

Building Roofing. The clubhouse building is roofed with a flat membrane system and asphalt shingles. The flat roof areas have an EPDM fully adhered membrane that is approximately 15 years old. The roof remains in overall good condition with only minor seam adhesive failure observed. The roofing and all the seams should be inspected annually and repaired as-needed. Flat roofing systems typically have a useful life of 15 to 25 years.

The asphalt shingle roofing is in overall good condition with the exception of a section of shingle that has come loose above the entry portico and a damaged shingle on the right front corner of the building. Asphalt shingle roofs can have a useful life of 20 to 50 years depending on the weight and quality of the shingle. Weathered, curled, and missing shingles are all indications that the shingles may be nearing the end of their useful life.
